UNDERWATER BRIDGE INSPECTION REPORT

STRUCTURE NO. 31510
CSAH NO. 62
OVER THE
MISSISSIPPI RIVER
DISTRICT 1 - ITASCA COUNTY

PREPARED FOR THE
MINNESOTA DEPARTMENT OF TRANSPORTATION
BY
COLLINS ENGINEERS, INC.
JOB NO. 3512 (CEI 29)

MINNESOTA DEPARTMENT OF TRANSPORTATION
UNDERWATER BRIDGE INSPECTION

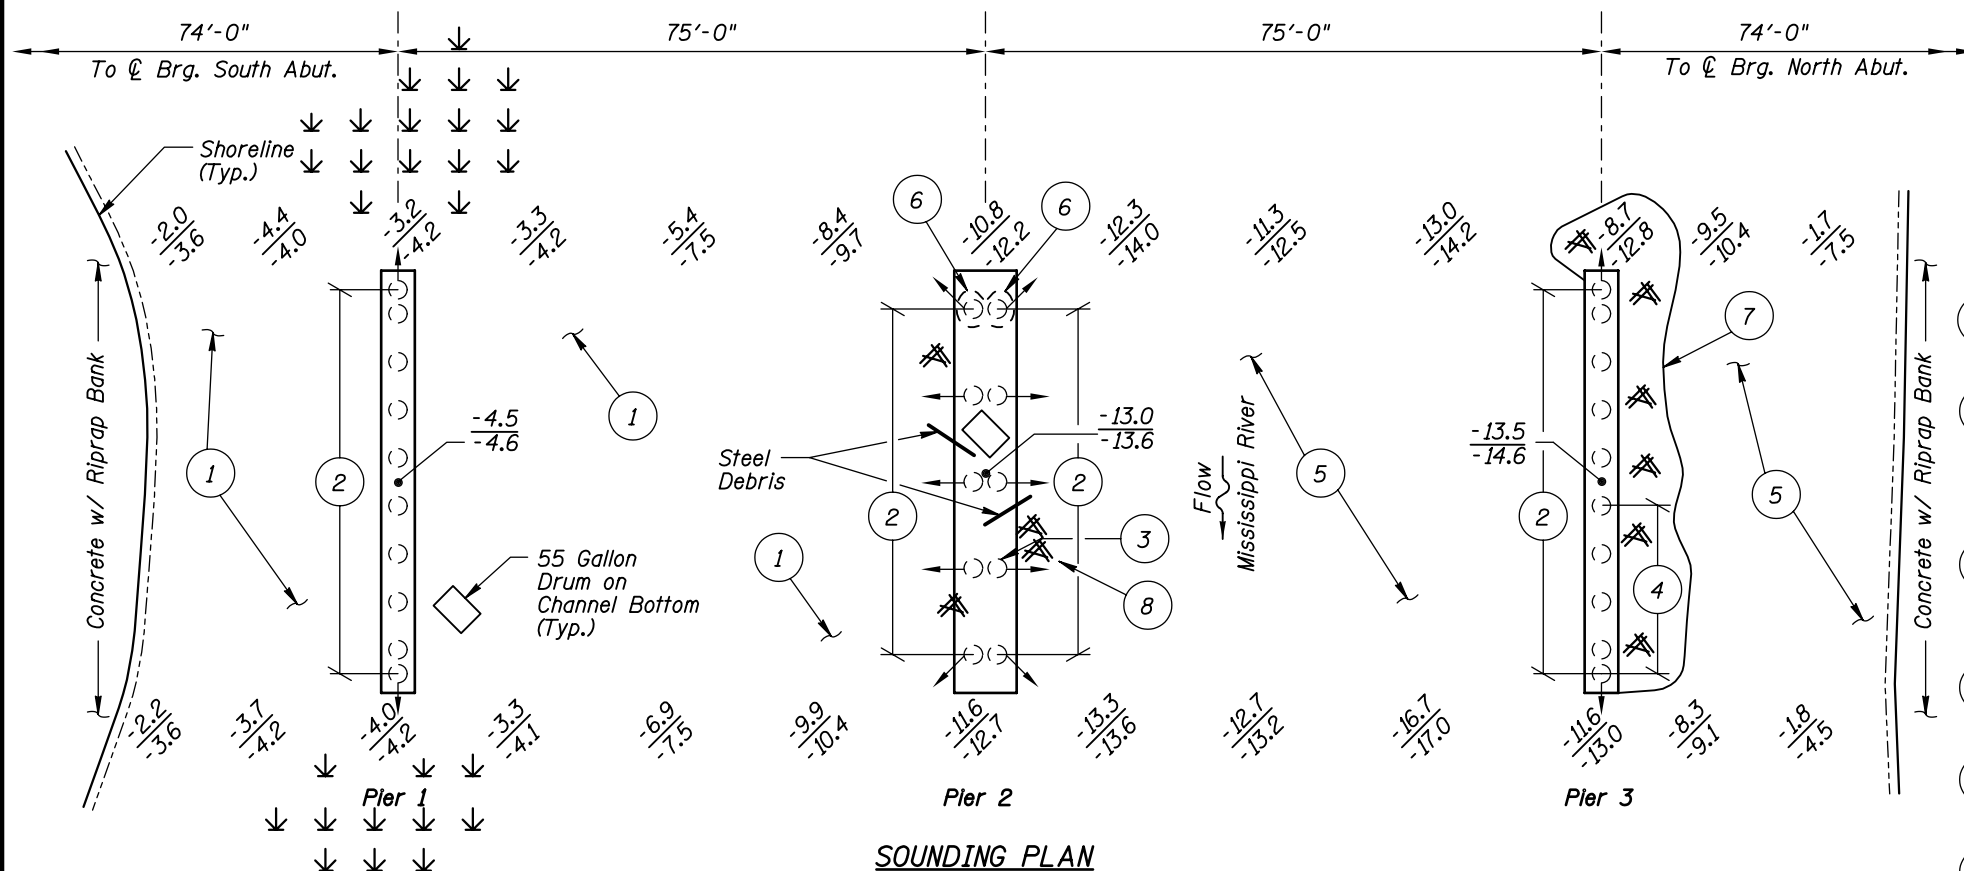
INSPECTION AND SOUNDING PLAN

- The channel bottom material consisted of soft silty sand with maximum probe rod penetrations of 1 foot.
- Moderate corrosion covered 75 to 100 percent of the pile surfaces from the waterline to the mudline. Minimal section loss was observed with typical pitting penetrations of no more than 1/32 inch and up to a maximum of 1/16 inch in random instances.

- Vertical crack along welded joint noted in previous inspection, August 27, 1997, has been repaired with a bolted steel collar extending from the underside of the pile cap to 9 feet below the waterline.

- Random heavy rust nodules extending from 3 feet below the waterline to the mudline.
- The channel bottom material consisted of firm sandy gravel with 6 inch to 2 foot diameter rocks and probe rod penetrations of 2 to 4 inches.

- Minor scour depressions, 1 to 2 foot deep with 1 to 2 foot radius, were observed around the upstream piles of Pier 2.
- Heavy accumulation of organics/vegetation was observed at the upstream nose and along the entire bank side of Pier 3 with occasional 1 foot diameter timber debris from the mudline up 3 to 4 feet above the channel bottom.

- Minor accumulation of 1 foot diameter timber debris was scattered on the channel bottom along the bent.

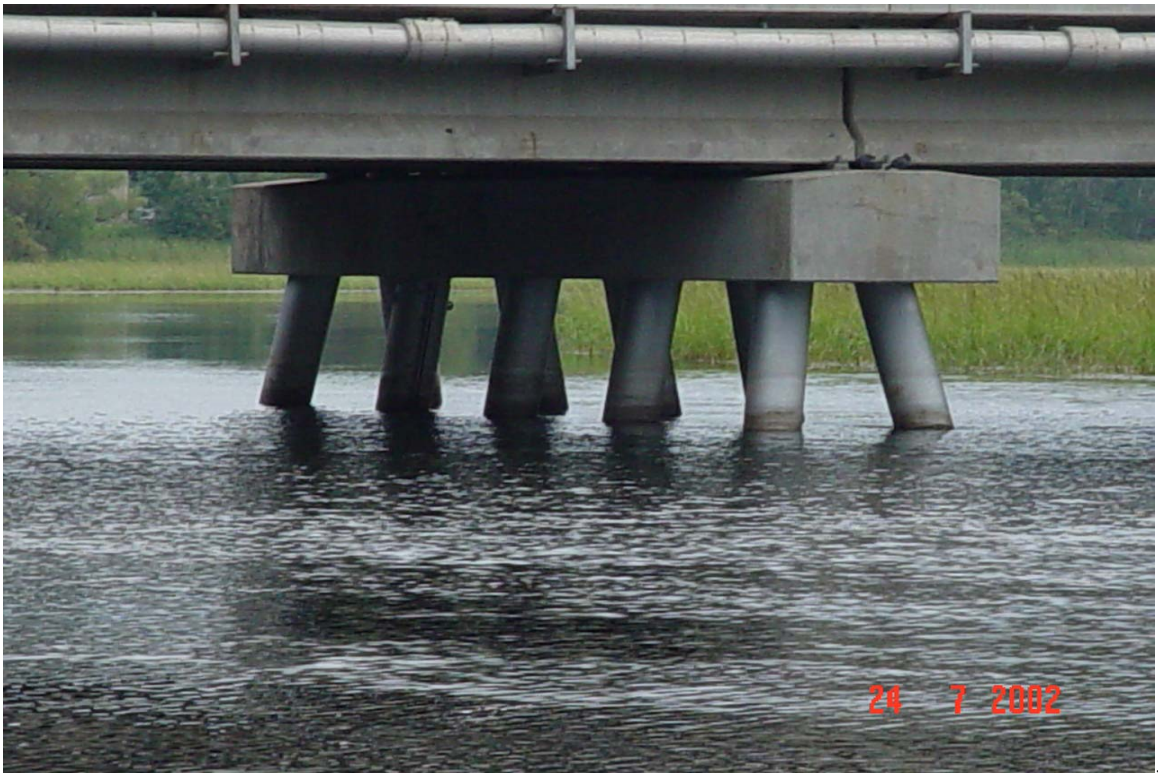
- (C) Minor scour depressions, 1 to 2 feet deep with a 1 to 2 foot radius, have developed around the two upstream piles of Pier 2 since the previous inspection.

Photograph 3. View of Pier 2, Looking Southeast.

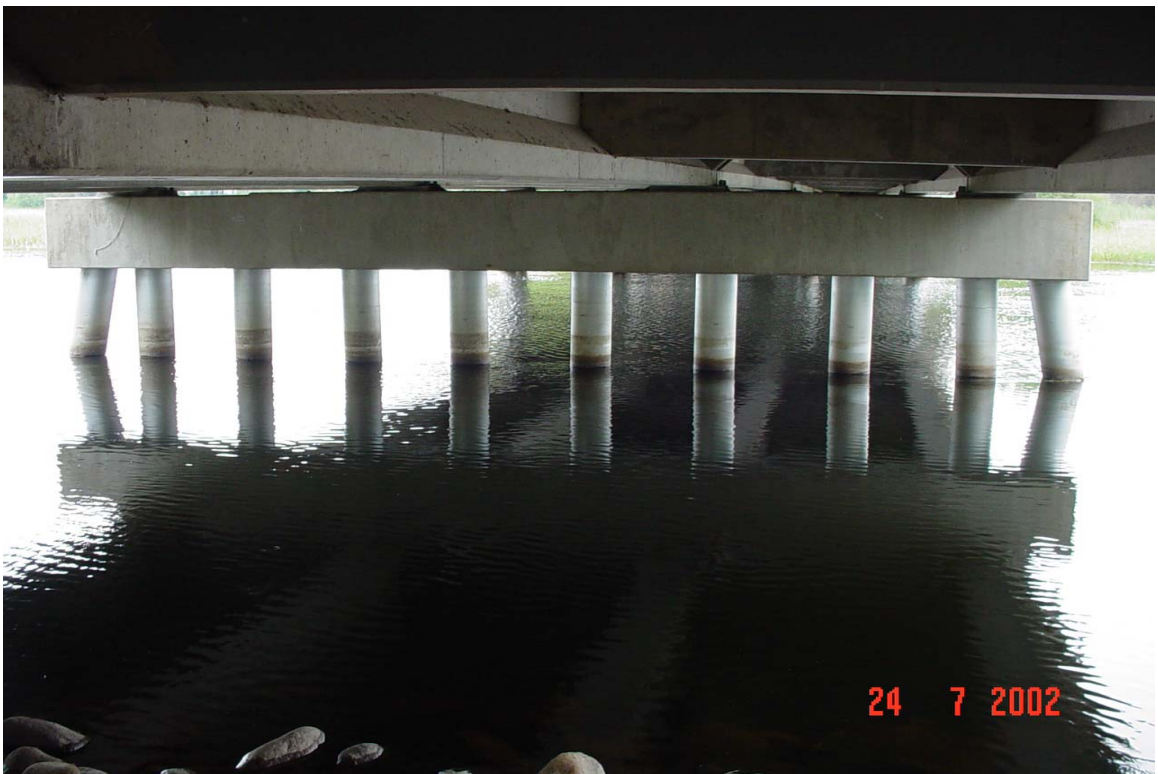
- (D) A heavy accumulation of organics/vegetation with occasional timber debris was observed at the upstream nose and along the entire bank side of Pier 3 from the channel bottom to 4 feet above the channel bottom. Scattered steel and timber debris was also observed on the channel bottom at Pier 2 along with a 55 gallon drum at both Piers 1 and 2.

Photograph 4. View of Pier 3, Looking South.

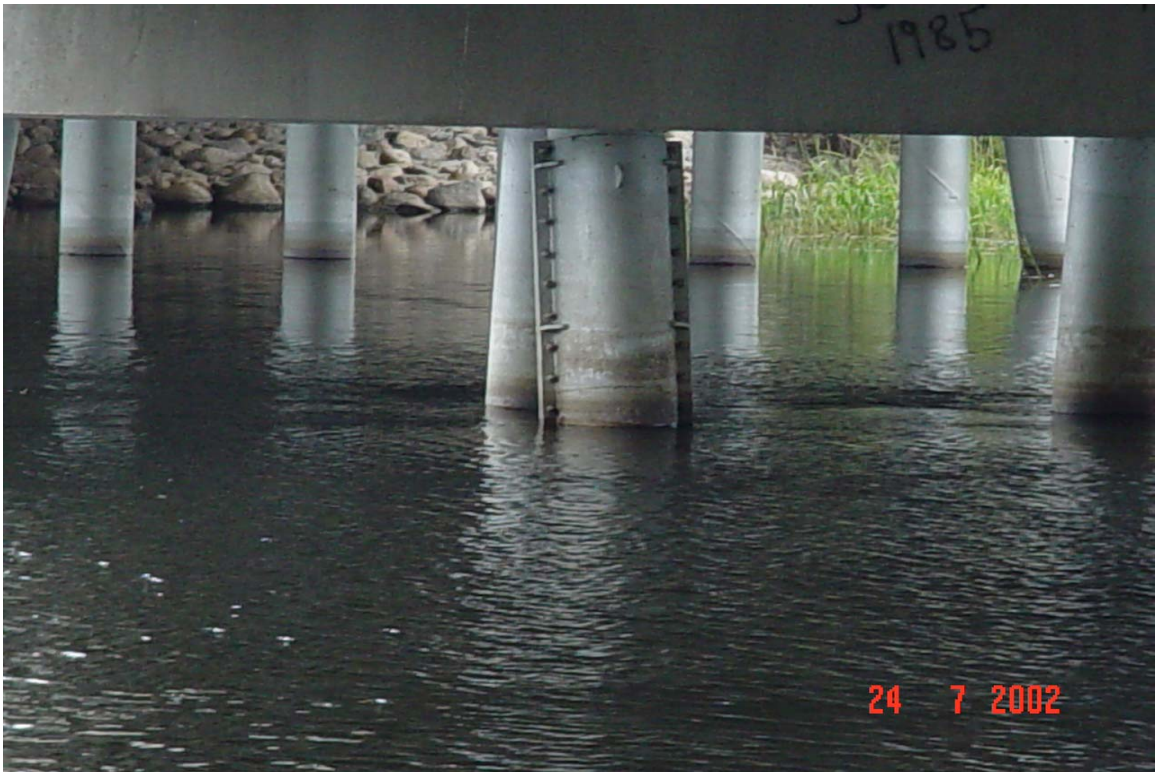
- (B) The vertical crack noted in the previous inspection has been adequately repaired with a bolted steel collar extending from the top of the pile to 9 feet below the waterline.

Photograph 5. View of Repair of Pile at Pier 2, Looking Southwest.
